Technical Note N-1197

DEVELOPMENT OF AN ELEVATED CAUSEWAY - SURF TESTS

B. R. Karrh

November 1971

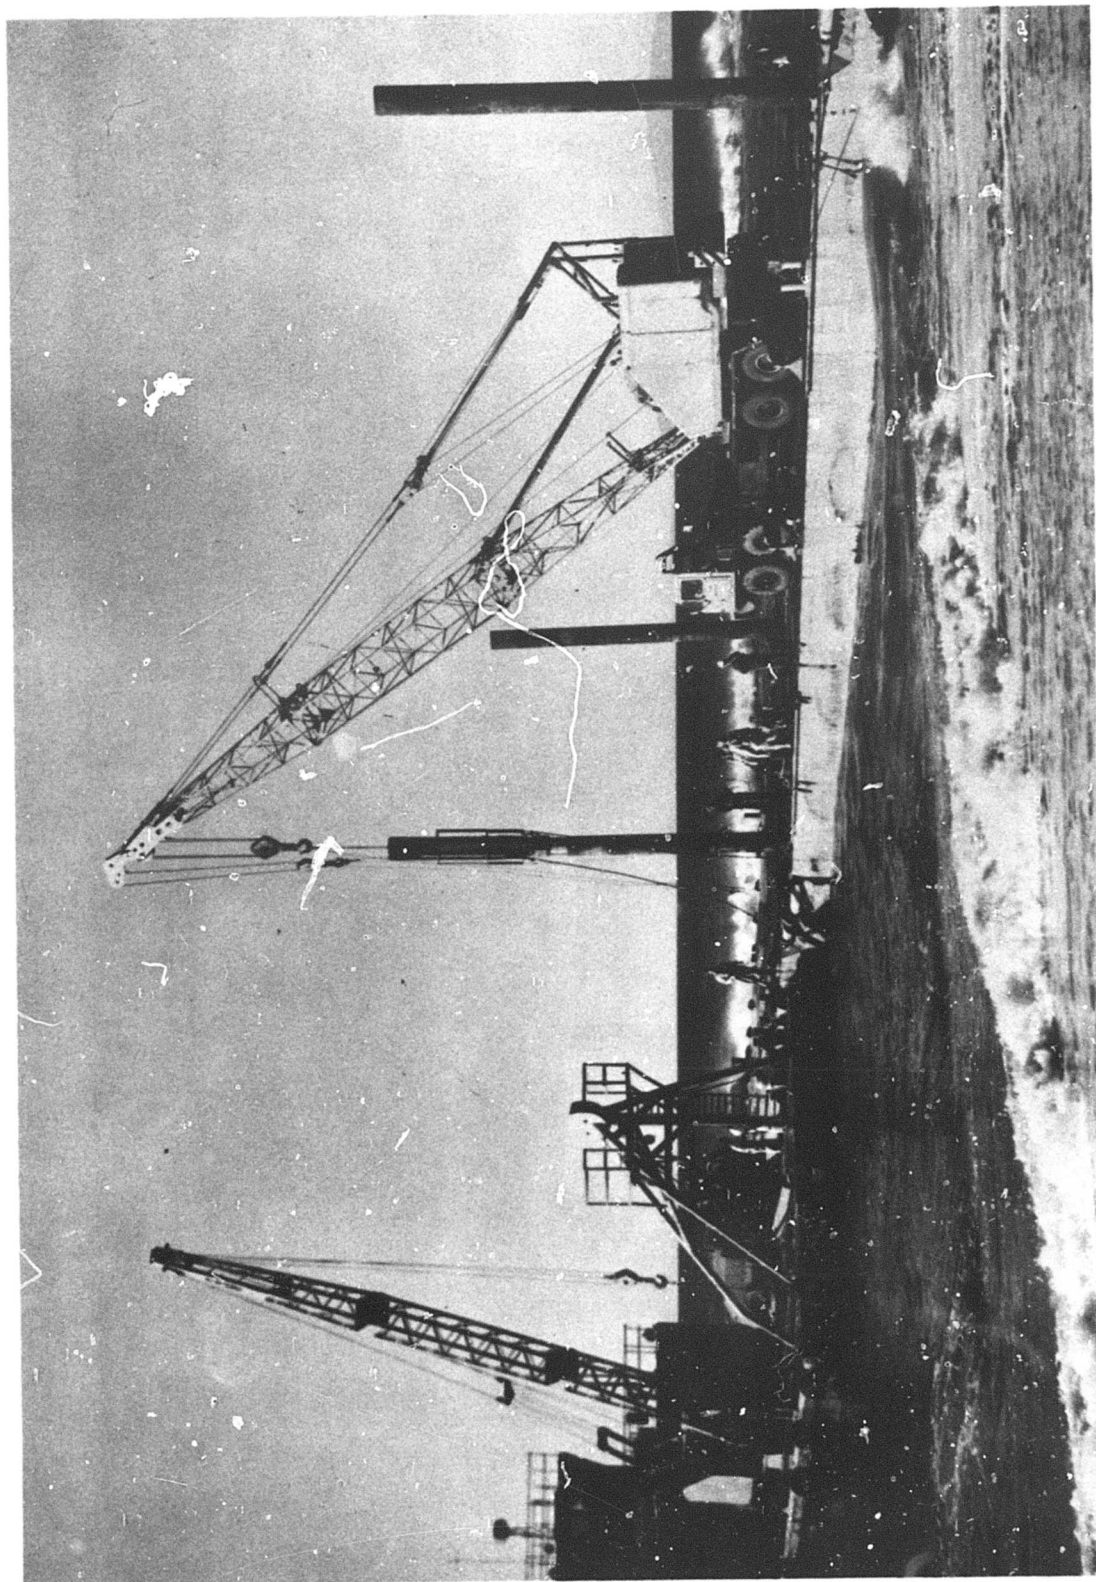
Figure 1. DE-20 diesel pile hammer with swinging leads
for driving piles.

The tests required the use of heavy equipment and hardware to support the operation. The NCEL warping tug, a flat-bottomed, sea going unit, was used to tow and maneuver the pontoon sections. A 50-ton truck crane was mounted aboard one section and an auxiliary pontoon section was utilized as a work platform to support the test. A rubber tired tractor and two bulldozers (D-8 and D-6) were used alternately as beach mooring points. An MKT DE-20 diesel pile hammer (16,000 foot-pounds energy) with swinging leads, shown in Figure 1, was used to drive the 20-inch diameter piles. To elevate the pontoon section on the four corner piles, a 12-part block and tackle gear (NAVFAC Drawing No. 1196232) was used with pile caps that were set in the end of each pile. The two bulldozers provided the driving force to operate the block and tackle gear. A large gasoline-engine driven winch was mounted on the auxiliary pontoon to provide the lifting force, but it was unusable when the surf was breaking over it (Figure 2). Other rigging gear was provided as required.

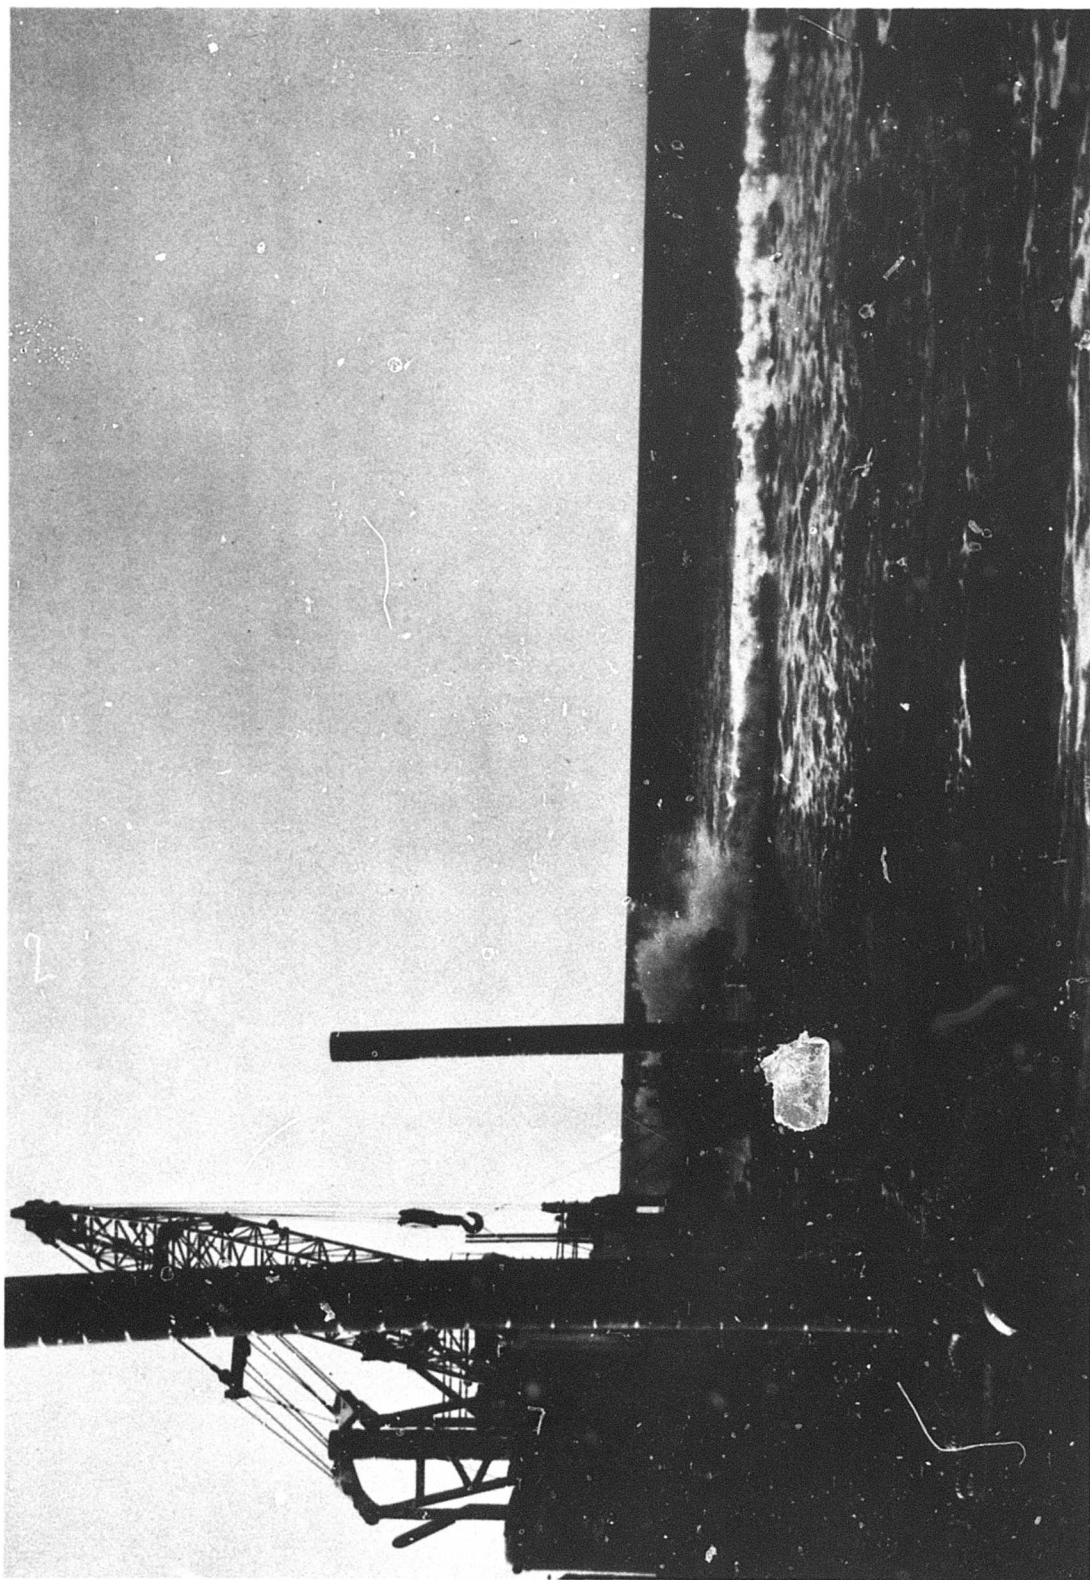
Figure 2. Surf breaking over pontoon and winch mounted on deck.

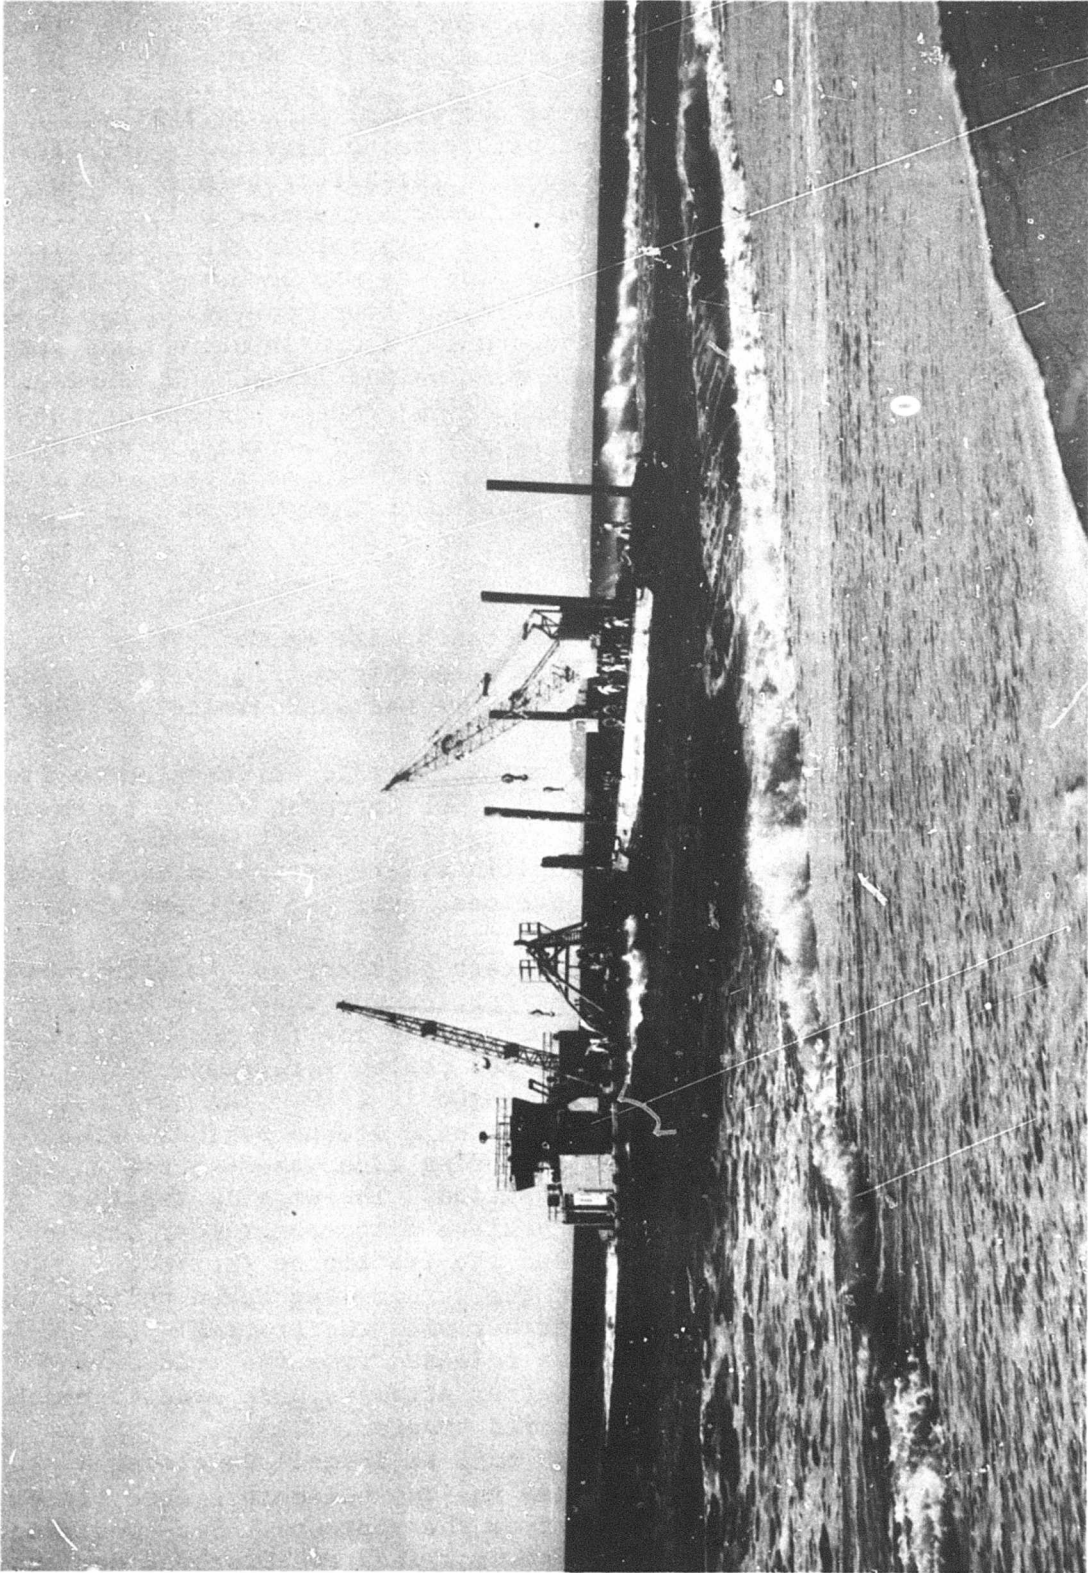
Figure 3. Approaching the beach for a test.

Near Shore Tests. The first attempt to install an elevated section at the beach was made on 4 December 1970. The approach to the beach with two connected pontoon sections lashed alongside the NCEL warping tug commenced at 0830 (Figure 3). Sea conditions were estimated as follows: offshore swell 2-3 feet at 15 second periods; surf 4-5 feet and 15 second period; wind negligible.

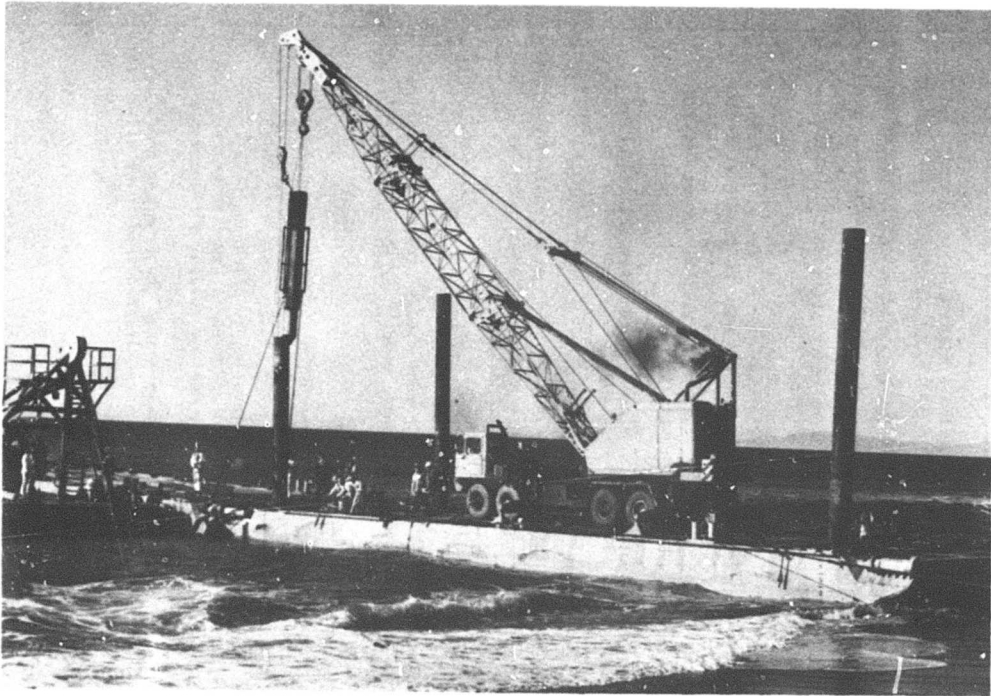
Figure 4. Tag lines to guide pile hammer into pile.

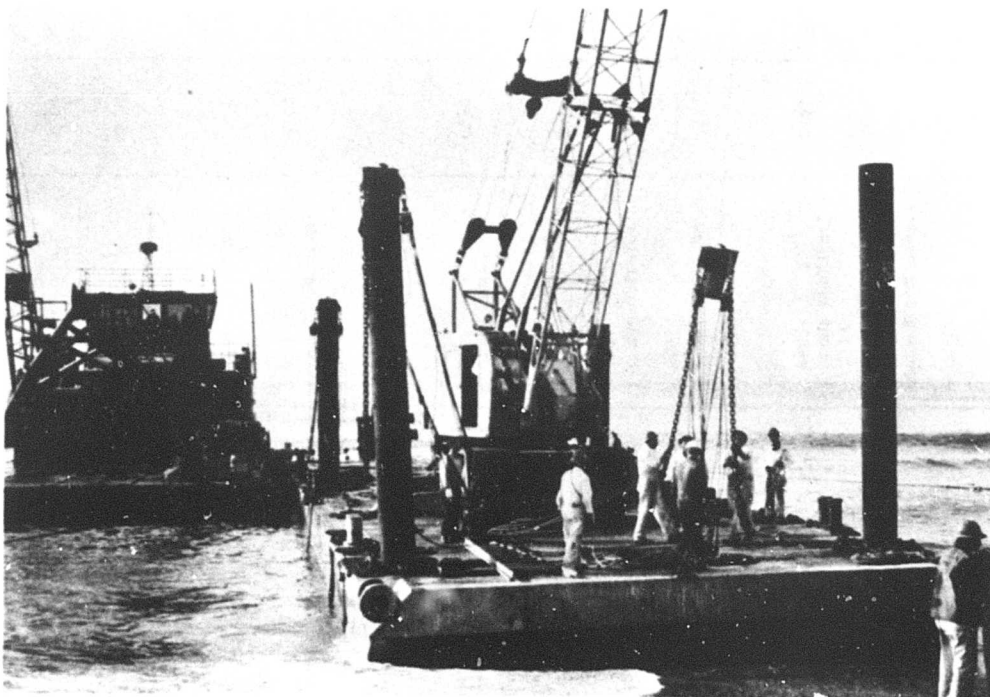
Figure 5. Placing pile caps, pre-rigged with block and tackle gear, atop the piles.

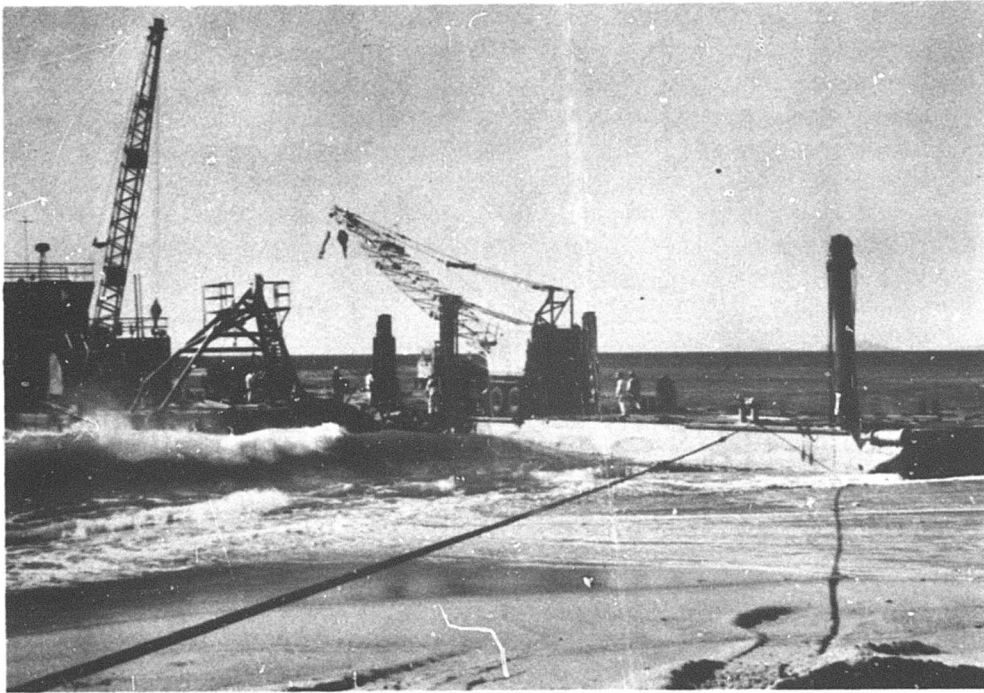
Figure 6. Transferring 50-ton crane to the auxiliary pontoon before elevating on piles.

The crane was then transferred to the adjacent pontoon section to permit the beached pontoon to be elevated. There was very little bending at the connection between the pontoons when the 50-ton crane rolled across (Figure 6). The auxiliary pontoon was disconnected in 30 minutes and removed from the test area by the warping tug.

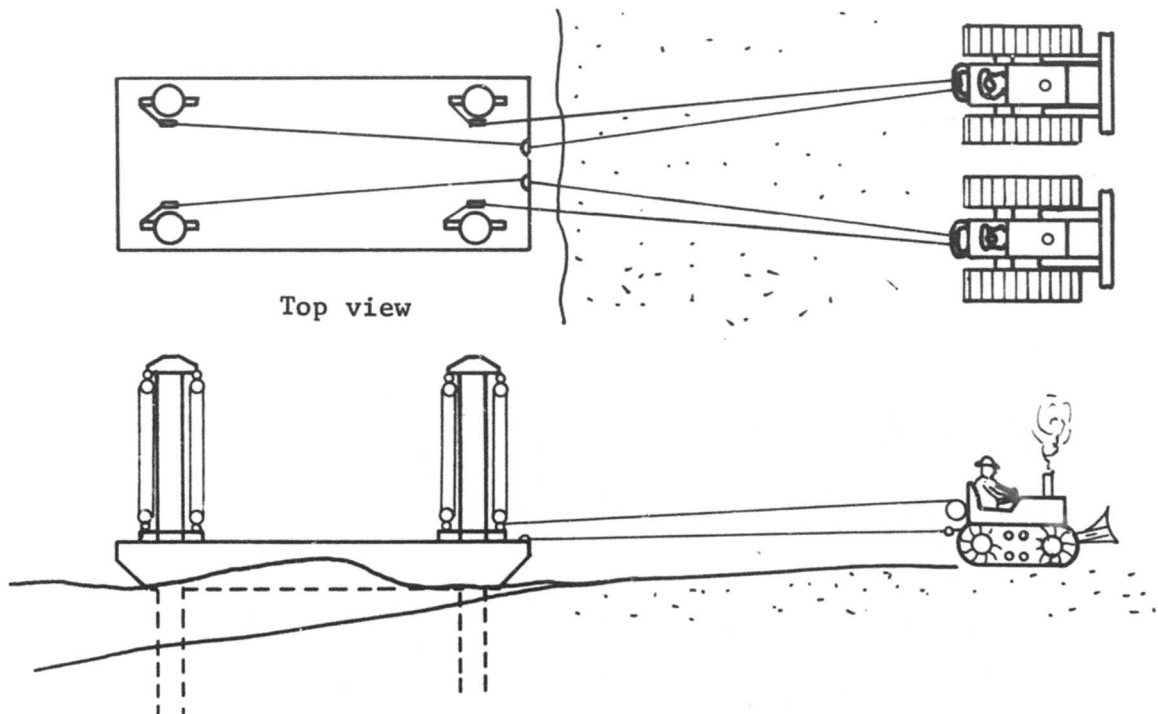
Figure 7. Technique for lifting pontoons with block and tackle gear and bulldozers.

To commence the lifting operation the dozers were positioned on the beach and a wire rope run from each of the four sets of block and tackle gear to the tractors as illustrated in Figure 7. The dozers then pulled slowly away lifting the pontoon. Minor adjustments were made in each line by taking up or letting off on a small winch on the tractors. The pontoon was elevated about six feet above the water level, as shown in Figure 8, to keep it above the water at high tide; elevating it to a higher level was not considered necessary to the test. The pontoon was elevated and secured in about 50 minutes. It could have been elevated higher at a rate of about 1 foot per minute.

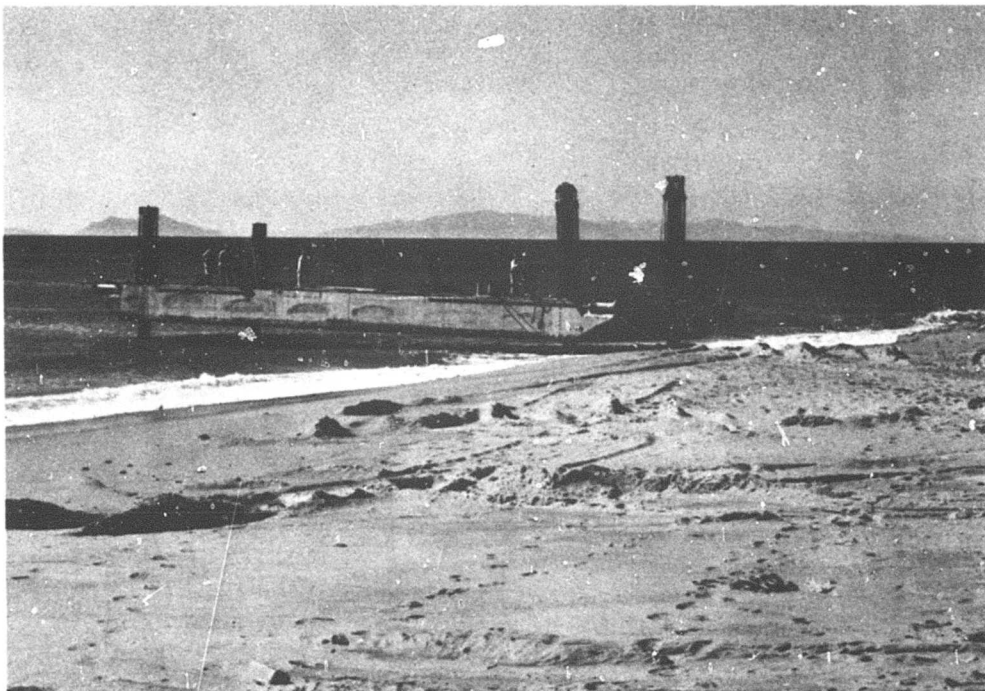
Figure 8. Ammi pontoon lifted out of surf by block and tackle gear.

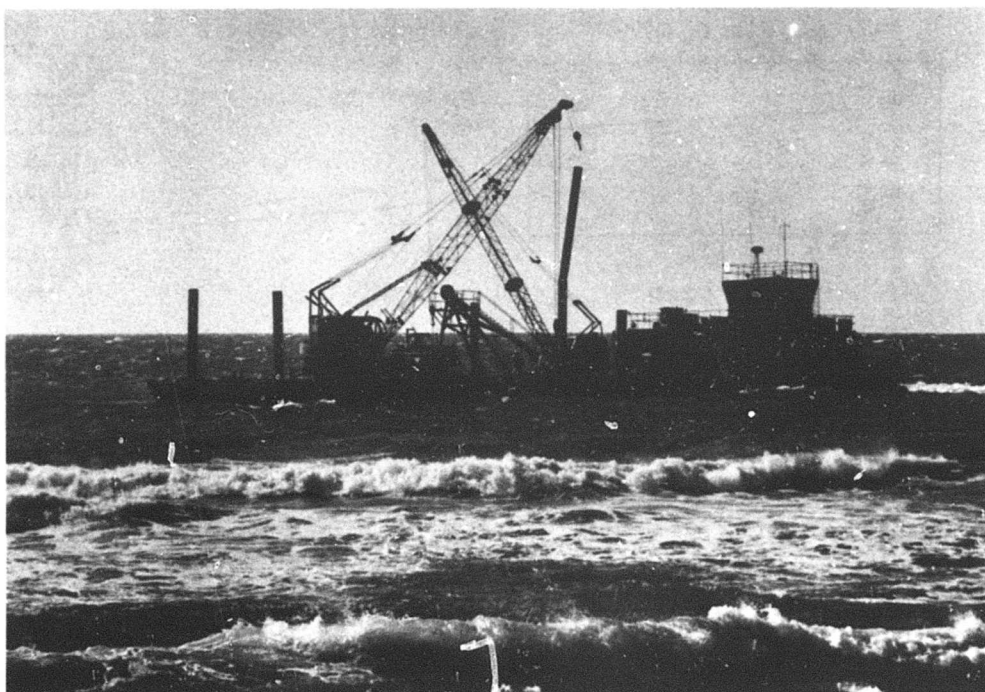
Figure 9. Moored position of warping tug and pontoons for offshore tests. Note pile damaged during tests.

The pontoons were towed to the site as in previous tests. Upon attempting to moor the pontoon perpendicular to the beach, the wind, waves and along-shore current swept the pontoons and warping tug along the beach. The anchors could not be set to hold them in place. Consequently, the two pontoons and the warping tug were moored in the line of least resistance to the prevailing wind, waves, and current, roughly at a 60-degree angle to the beach. The mooring operation was completed in about 50 minutes. The water depth where the pontoons were moored varied from 18-20 feet. Figure 9 shows the moored configuration.

During the offshore tests, one of the driven piles failed while it restrained the floating pontoon, as shown in Figure 9. The pile that failed was the first one driven. The failure probably occurred before the other three piles were driven because it was the primary restraint for the pontoon being pitched about in the wind and waves. The failure occurred at the bottom of the spudwell, most likely following local impact from the edge of the spudwell. The real significance of the failure is that it emphasizes the possibility of pile failure during the causeway installation.

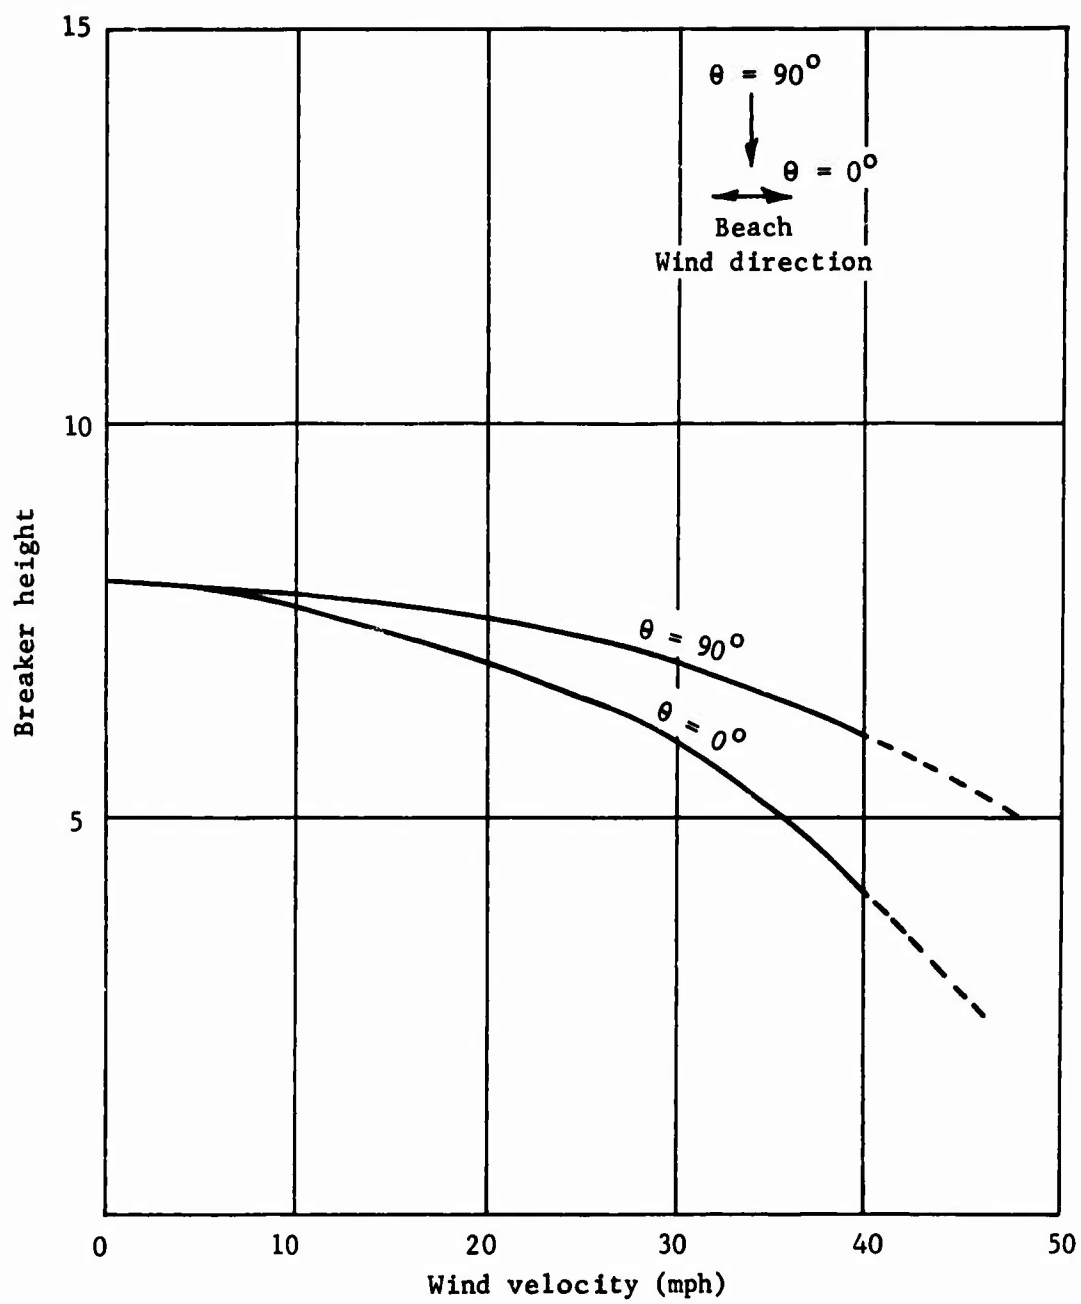
Figure 10. Estimated limits for installation of an elevated causeway through the surf zone.

The elevated pontoon installation in shallow water provided information about the limiting conditions for similar operations on a full scale. Limiting surf conditions are relevant to two operational phases: (1) beaching and mooring the causeway and (2) operations associated with pile placement and driving. The beaching and mooring phase is critical in the surf zone, while pile placement and driving operations may be critical in deep water as well.

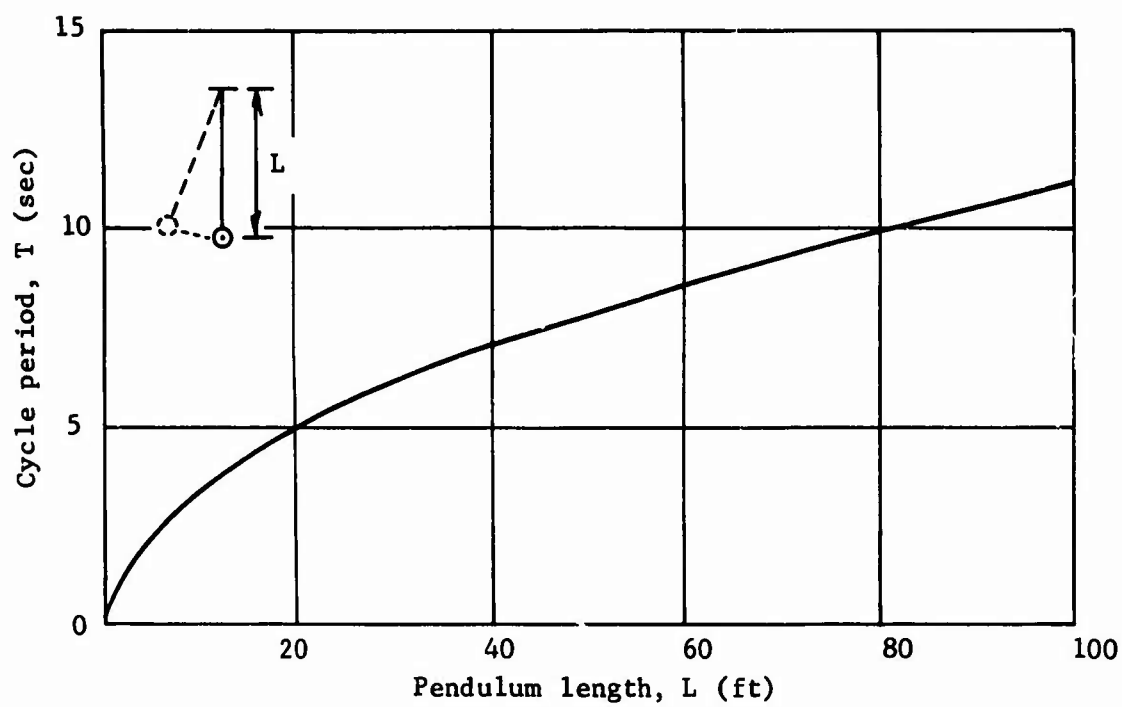
Figure 11. Cycle period of pendulum as a function of length.

Pendulum motion (swinging) of a load at the crane hook amplifies the rigid body motion experienced by the crane and pontoon, as a result of heave and pitch, and makes operations more difficult. Figure 11 shows a plot of the natural period of a pendulum as a function of the pendulum length. If the predominant wave periods are in the range of the pendulum's natural period, then we would expect the swinging motion of the load to be amplified by the waves. When the wave period and pendulum period differ considerably, the swinging motion will be erratic and not so severe as when the periods are a near match. For example, consider a load on the hook with a 40-foot line. The natural pendulum period is about 7 seconds. Therefore, waves in the 6-8 second period range are likely to cause the greatest swinging motion of the load. Motions of a crane-hook load due to sea excitations are being investigated in a current study.⁵

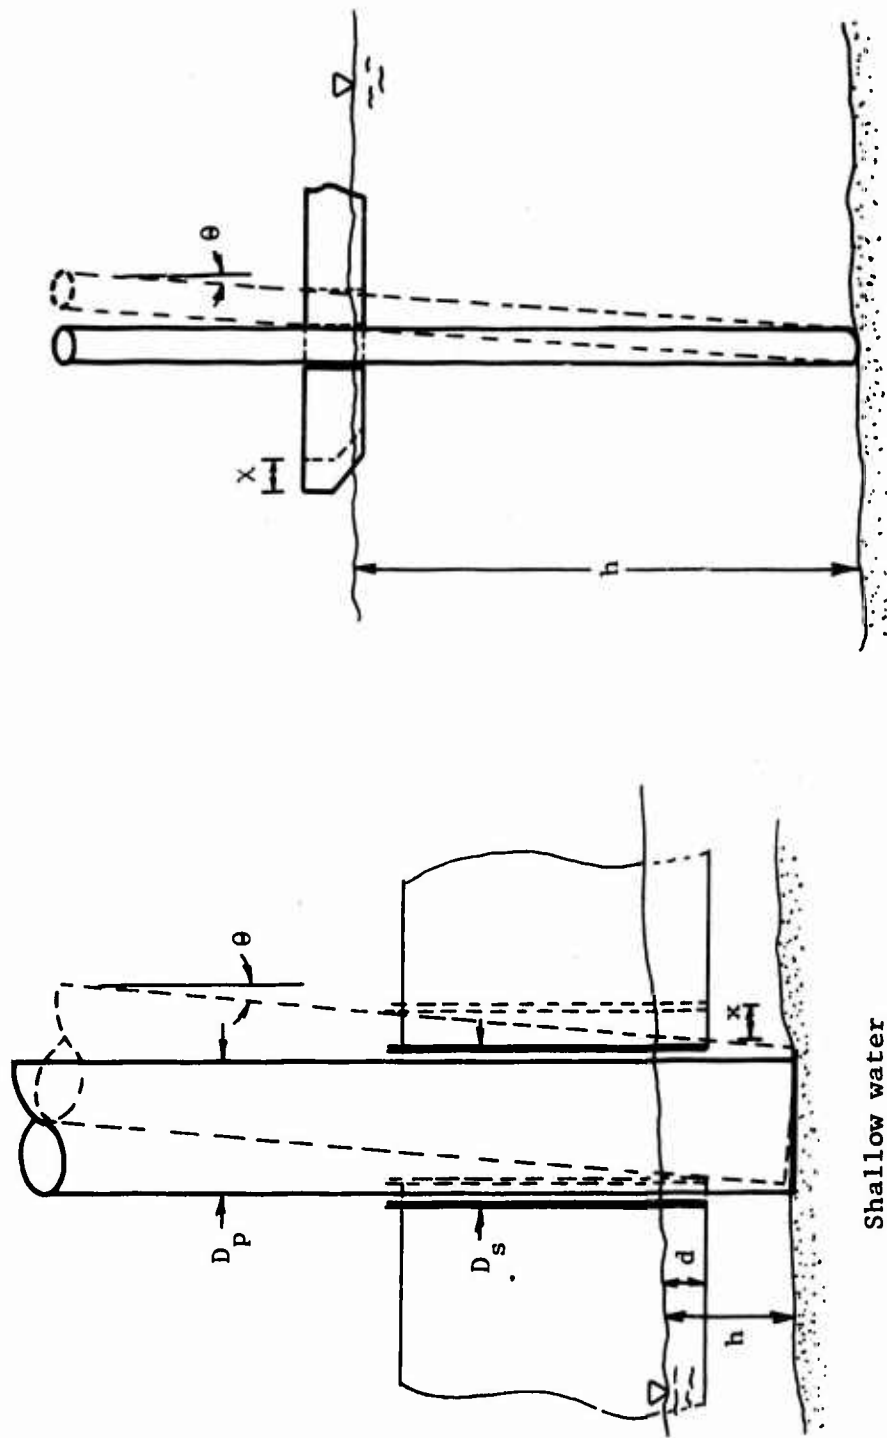
Figure 12. Effect of pontoon translation on vertical orientation of piles.

Consider the effect of pontoon heave, surge and pitch on vertical pile orientation. Heave motions are purely vertical and do not create a problem. To observe the effects of surge and pitch, consider a spudwell several inches larger than the pile, which permits the pile to rotate through an angle, θ , inside the spudwell. Figure 12 shows the effect of horizontal pontoon movement (surge) on a pile resting on the bottom in shallow water and in deep water. Small movements in shallow water cause the pile to tilt up to the maximum possible angle; however, in deep water movements must be much greater to tilt the pile. Figure 13 reflects the critical placement of the pile on the bottom and its effect upon vertical orientation of the pile. To demonstrate the effects of pontoon pitch on vertical pile orientation, consider a pile which fits snugly in the spudwell. Three things can happen: (1) the pile can rotate with the pontoon, (2) the pontoon can be restrained from pitching, or (3) the pile can fail at the spudwell. Figure 14 shows how the pile is likely to react in shallow and in deep water. It is intuitively apparent that neither of the above circumstances lends itself to precise vertical pile orientation; therefore, by elimination, the pile-spudwell geometry should allow the pile to rotate in the spudwell. The problem then reverts to finding a method of attaining vertical pile orientation within an oversized spudwell.

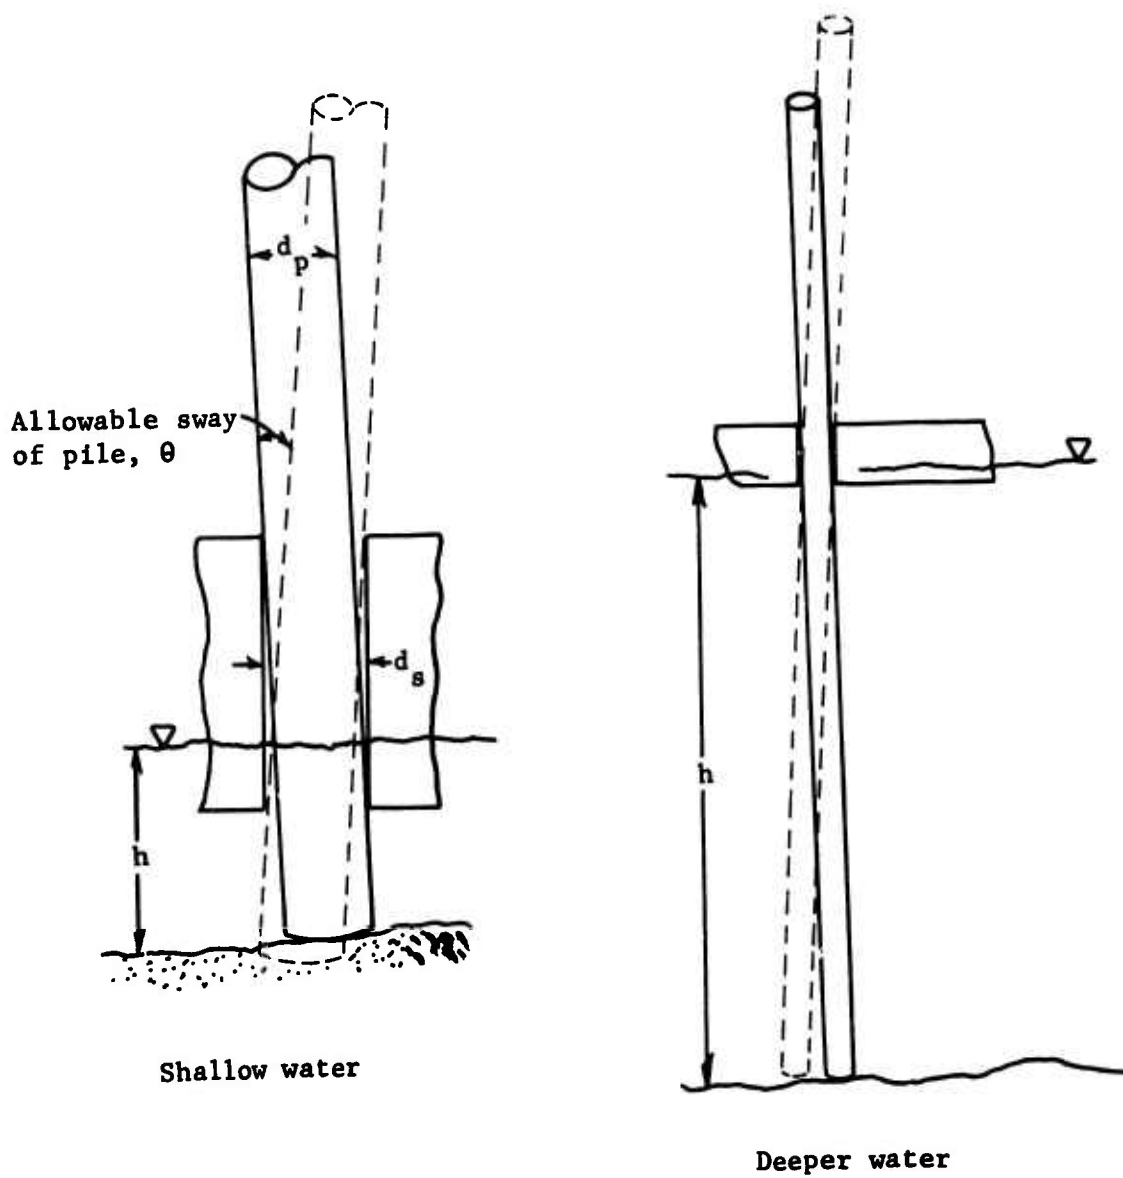
Figure 13. Effect of bottom position of pile on vertical orientation.

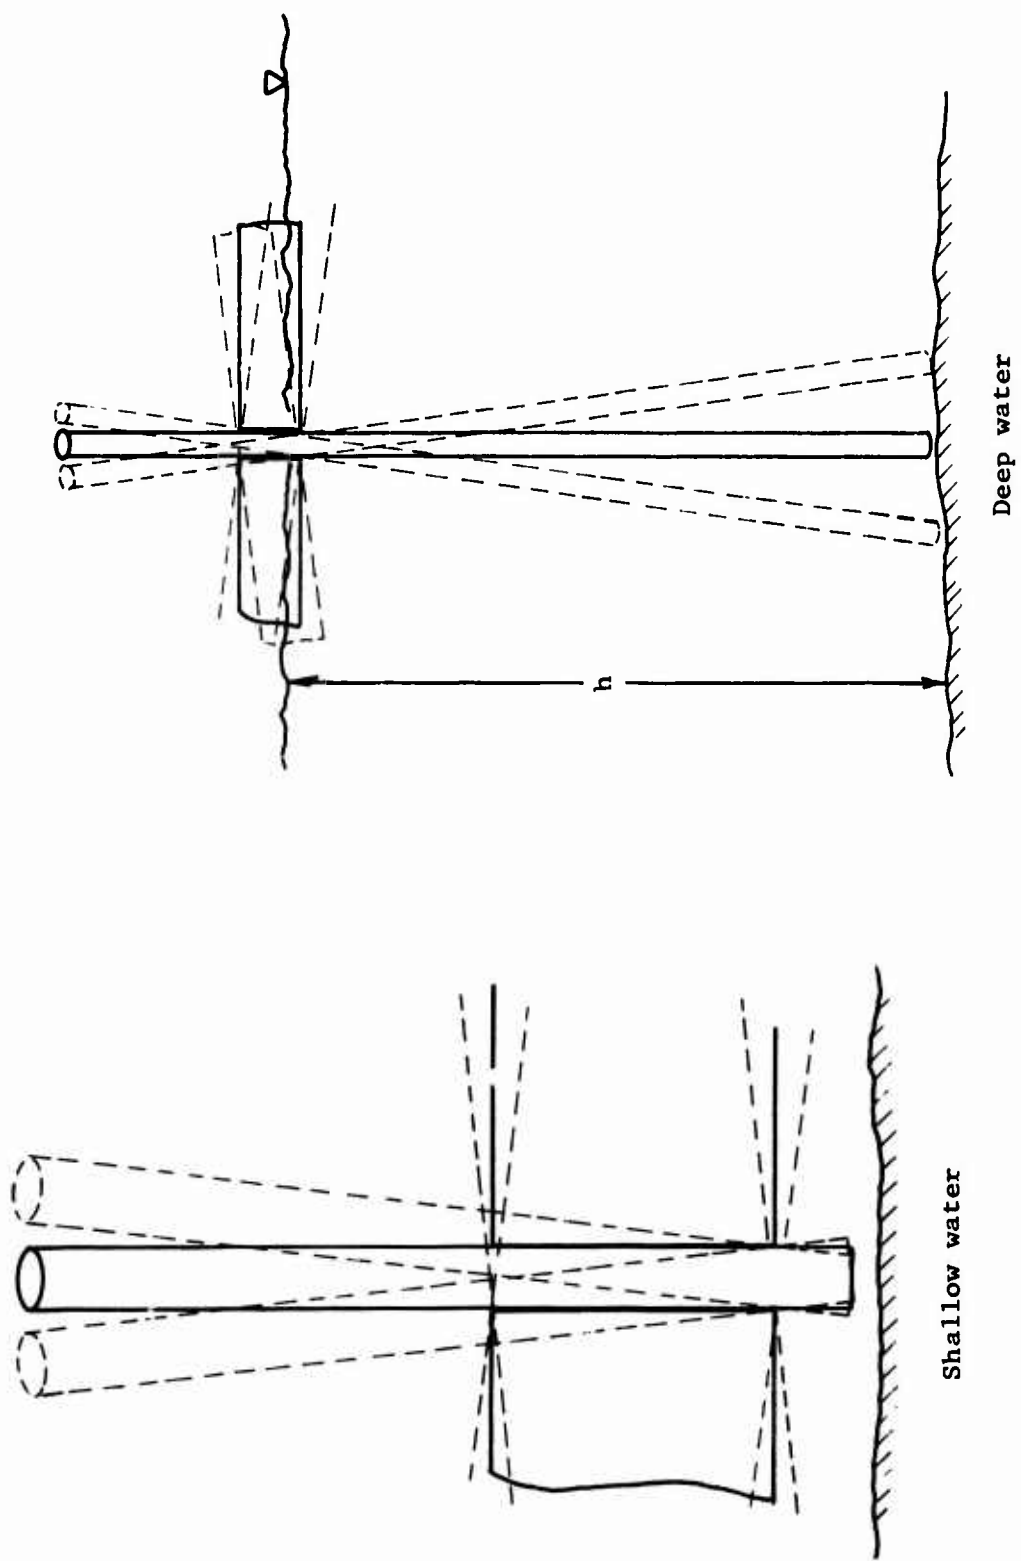
Figure 14. Effect of pontoon pitch on piles and spudwells.

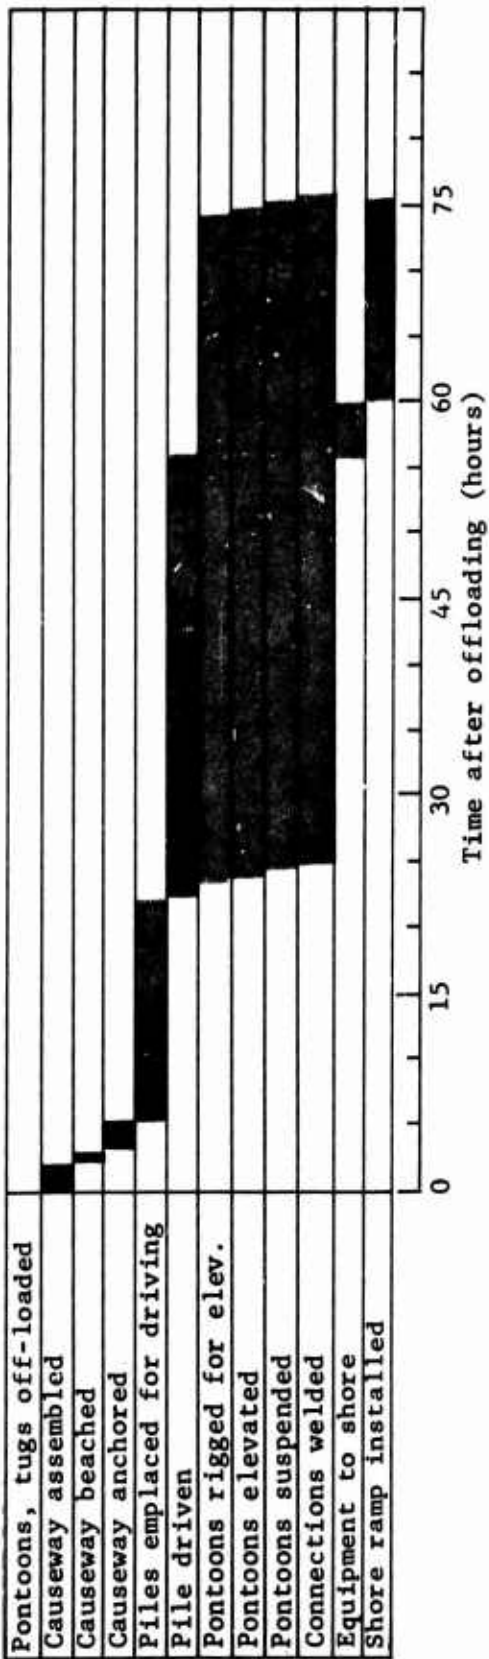
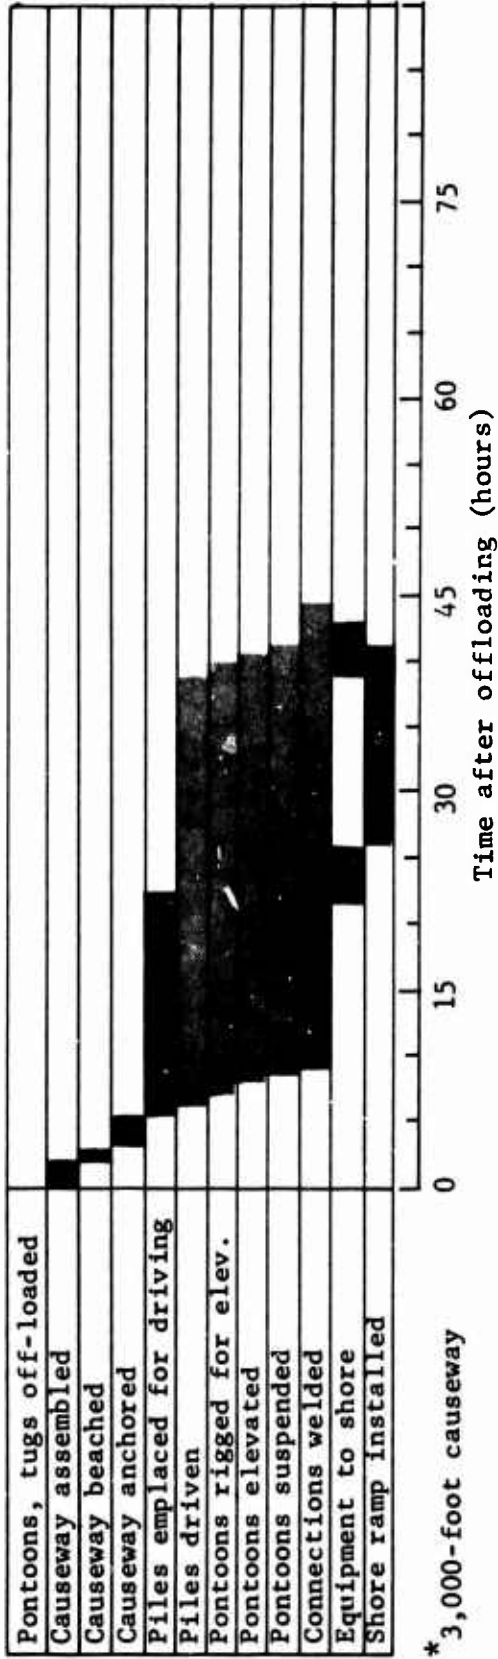
Figure 15. Simulated installation of a 3,000-foot elevated causeway for 1 and 2 work crews and installation sequence lb.

Estimates derived from the test data can be extrapolated to simulate the installation of a causeway on an open beach. Table 2 estimates time, men, and equipment required to install a 3,000-foot causeway using 1 or 2 work crews. Figure 15 shows the results of a simulated installation of a 3,000-foot causeway using first one, then two work crews using sequence 1b technique. The simulation estimates 77 and 45 hours, respectively, to install a 3,000 foot elevated causeway with one and two work crews (no shore crew). A further derivation of the time-man-power-equipment data is compiled in the plot of Figure 16. Here, the time required to install an elevated causeway is estimated as a function of the causeway length for one work crew and for two work crews. Two alternatives are included. The alternatives provide an additional shore crew to construct the causeway beach interface while the elevation operations are in progress. The plot indicates that it becomes more efficient (timewise) to provide the shore crew as the causeway becomes shorter than 2,700 feet.

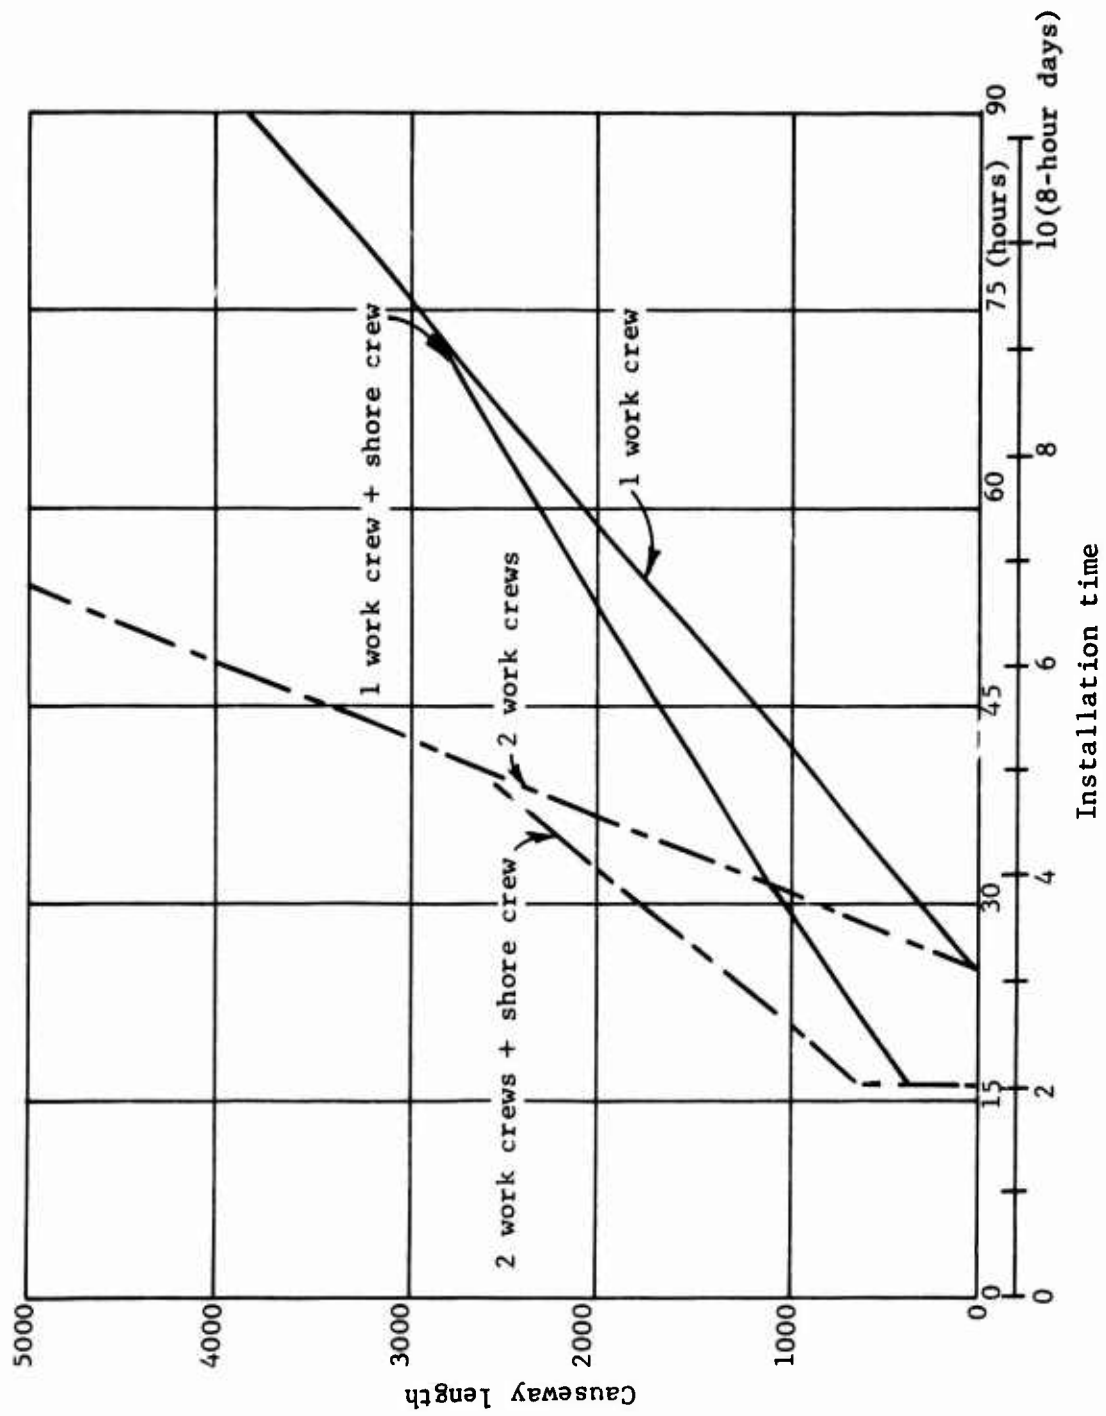
Figure 16. Comparison of installation time for 1 and 2 work crews using installation sequence 1b.

8. Estimates of the installation operation indicate that two work crews can install a 3,000-foot causeway about 40 percent faster than a single crew. A supplementary shore crew becomes advantageous for causeway lengths less than 2,000 feet.
